(BUREAU OF SHIPS GROUP
TECHNICAL INSPECTION REPORT.

⑥ OPERATION CROSSROADS.
U.S.S. MUSTIN (DD413).

TEST BAKER [U].

BUREAU OF SHIPS GROUP
TECHNICAL INSPECTION REPORT

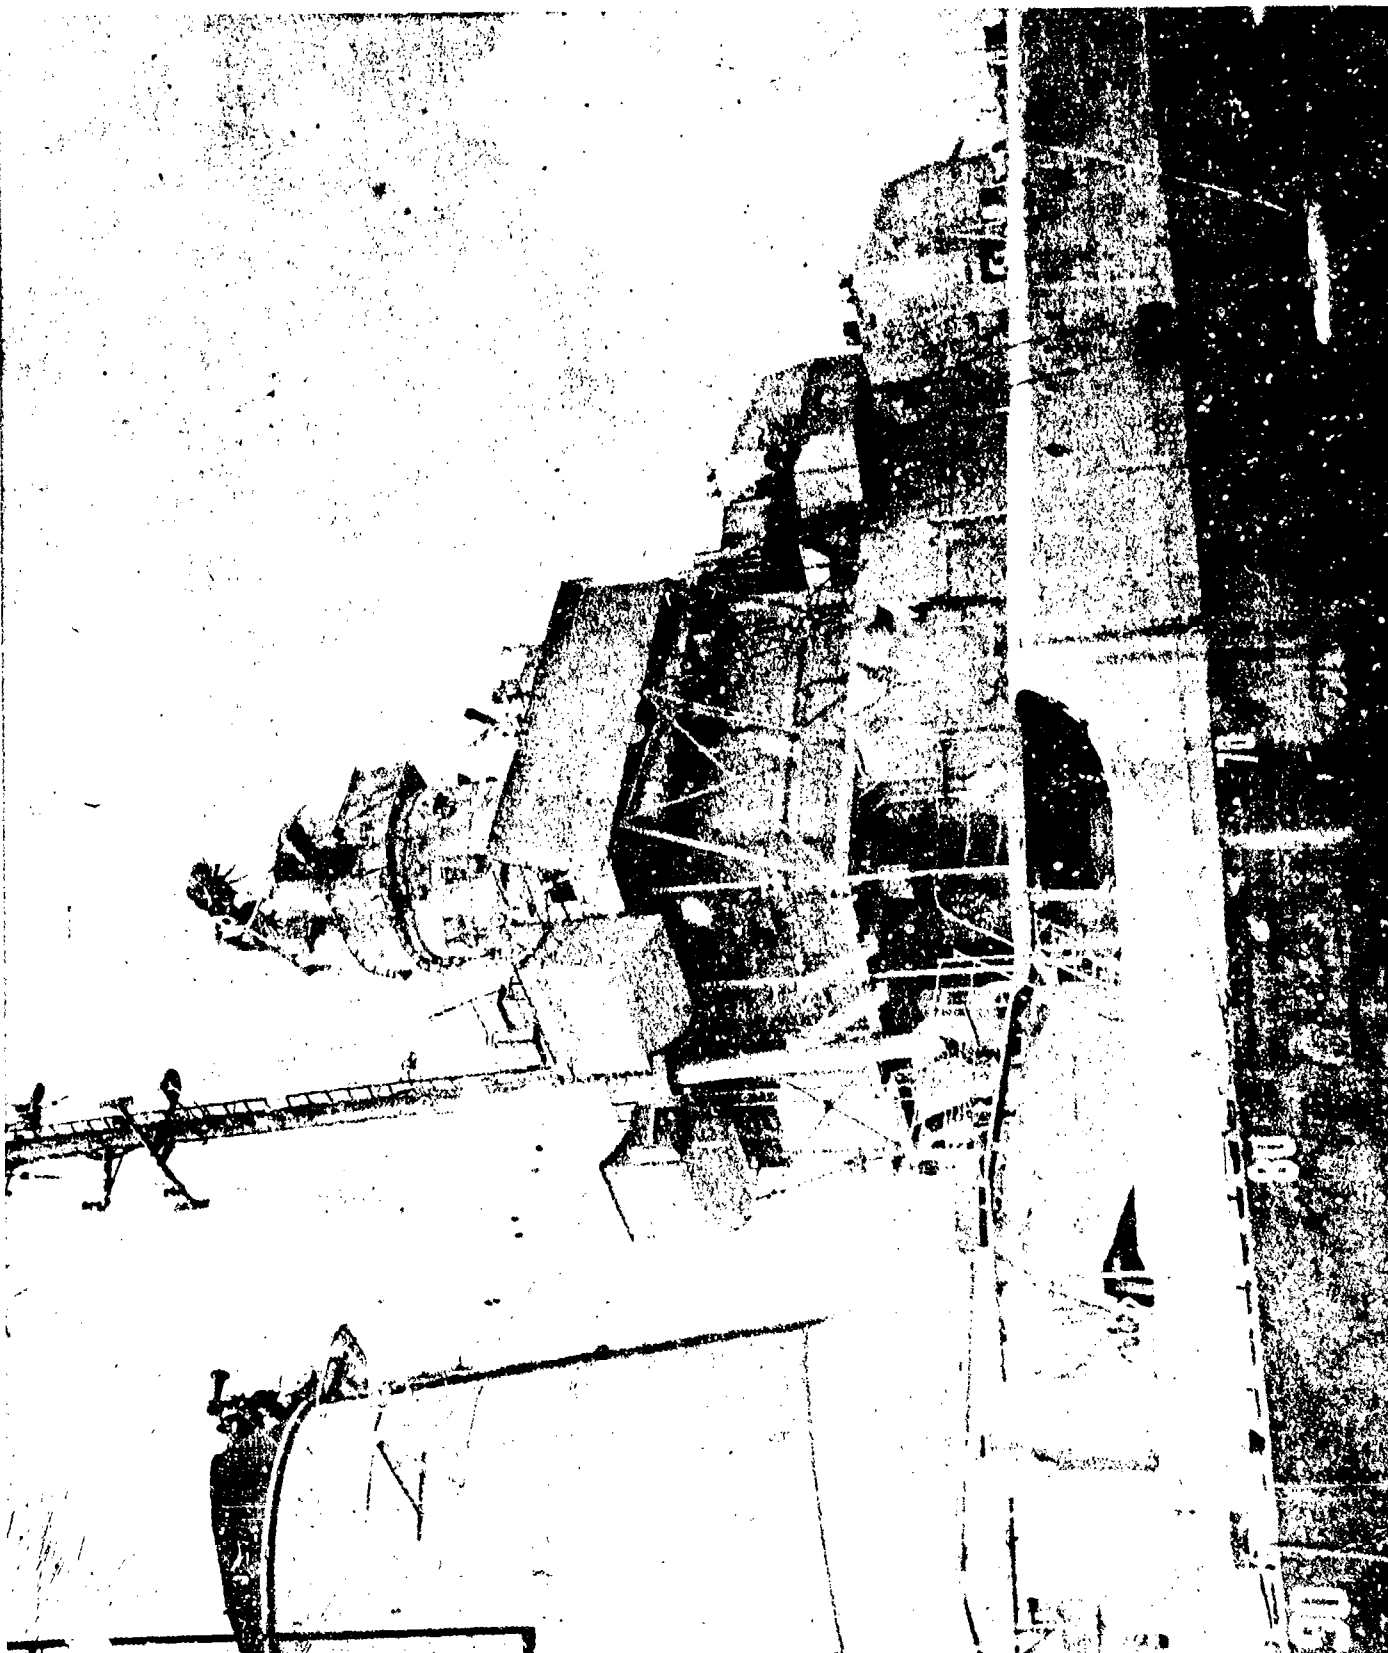
The stack breeching on the starboard side is badly dished and failed at the seams in a number of places because of failure of spot-welded lap joints. It was ruptured in way of transverse tie bolts. (Photographs 2175-5, page 48, 1933-3, page 49, 1933-4, page 50, and 2186-7, page 45). Stack breeching on the port side is only slightly damaged.

AB-CR-175-2186-7. Starboard side close-up, bow to stack after Test B.

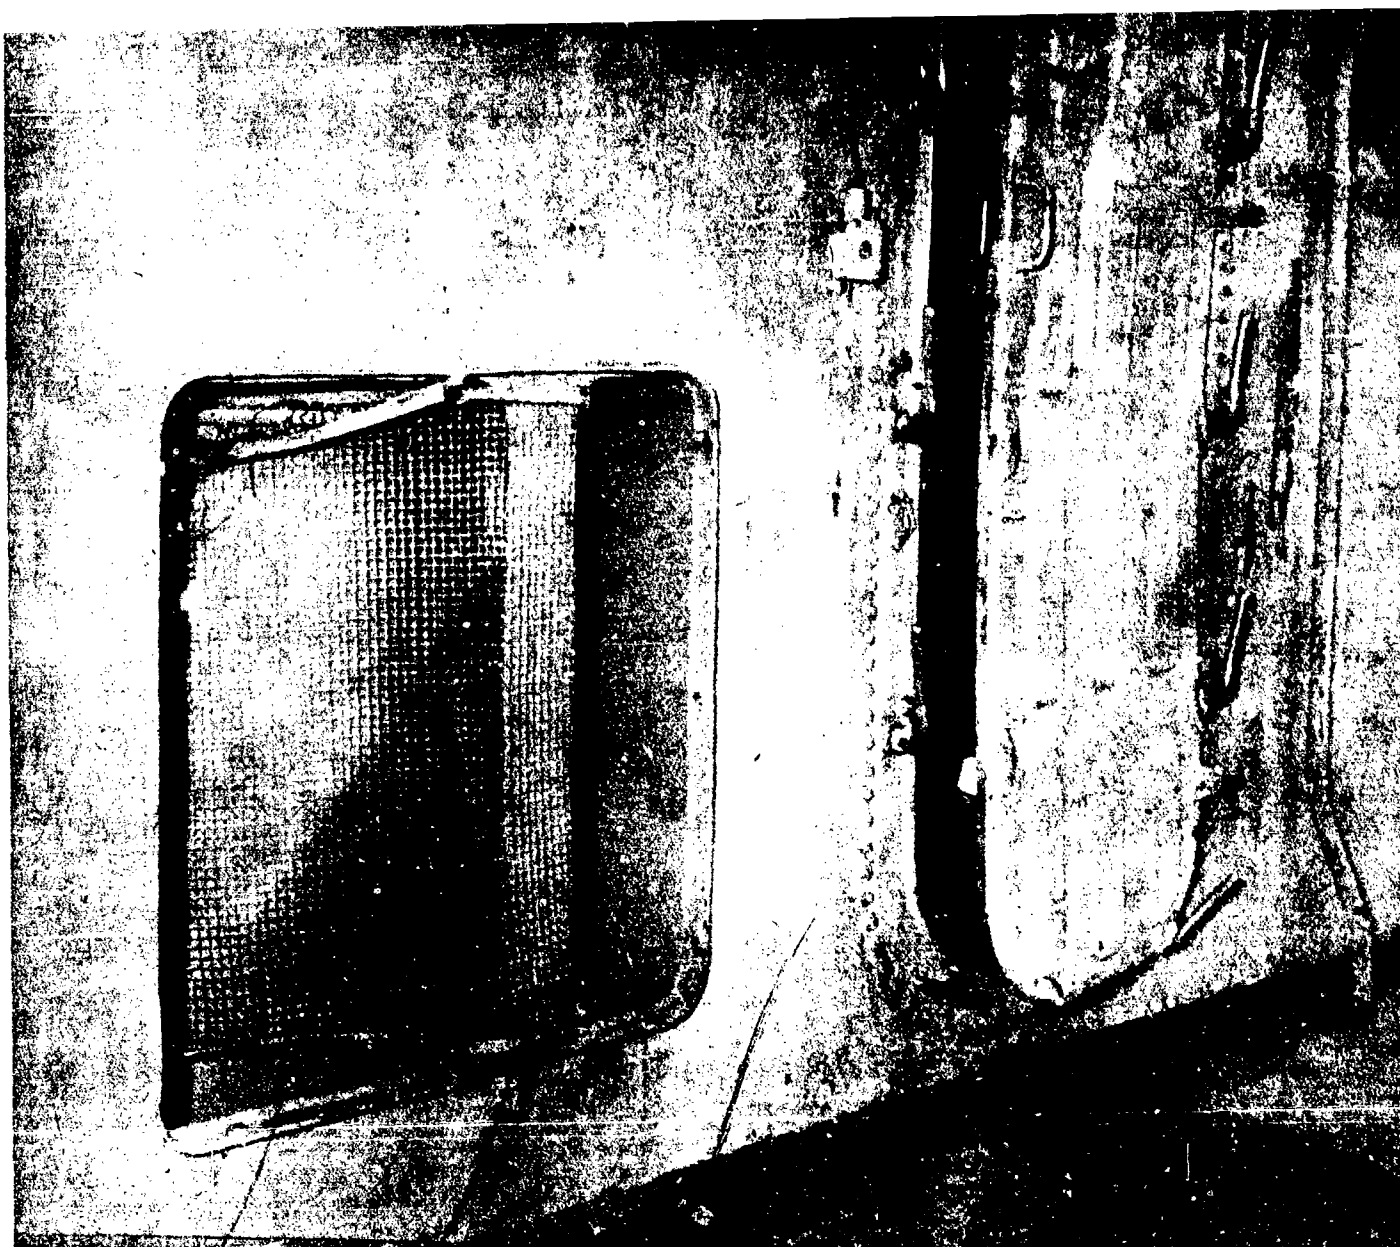
A number of wire mesh screens over ventilation intakes opening onto the weather deck were dished or ruptured, principally on the starboard side of the ship. (Photographs 2175-7, page 51).

Panel deflection under blast is evidence by dishing of
a watertight door at frame 105, starboard, and by damaged stack
breaching and ventilation screens.

AB-CR-62-2175-7. Damage to door and blower duct screen frame
105, main deck, starboard.
